NASA/TP-2009-214769

A Summary of NASA and USAF Hypergolic Propellant Related Spills and Fires

B. M. Nufer
Kennedy Space Center, Florida

June 2009

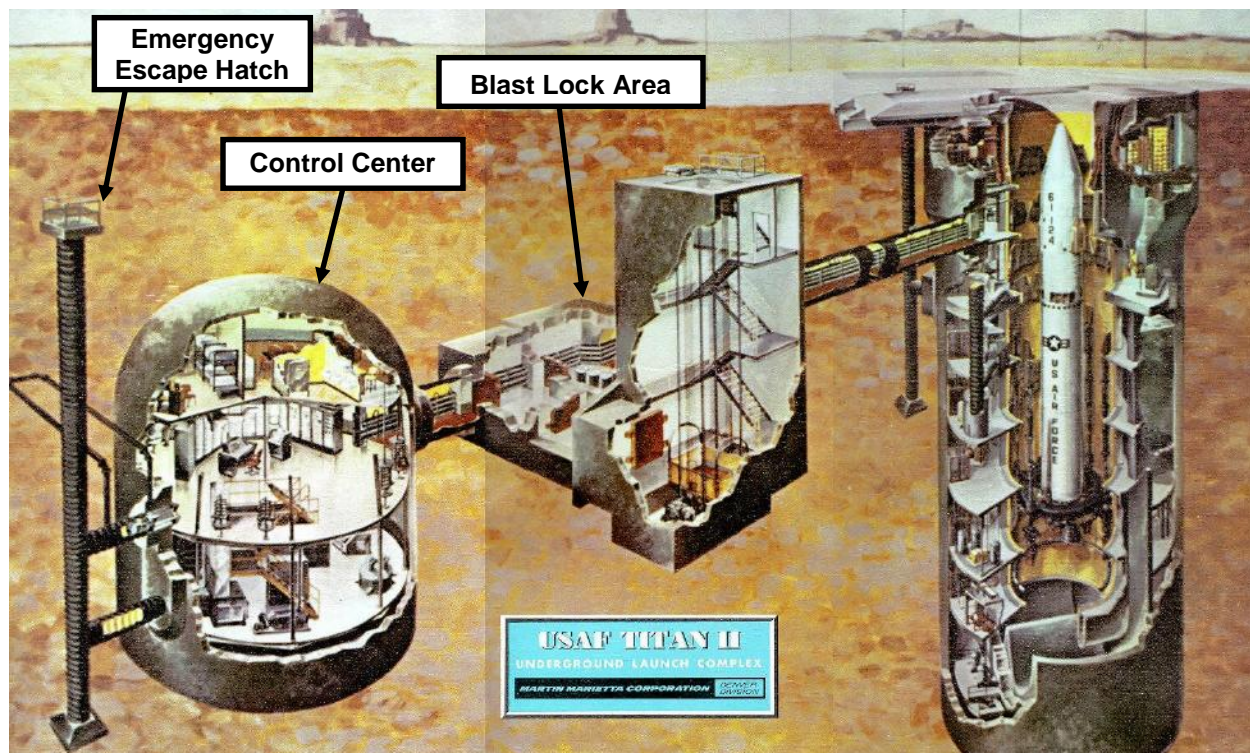
Figure 5-1: Underground Titan II Missile Complex

Very high concentrations of NO₂ vapors traveled from the silo into the connecting cableway to the blast lock area, which was located just outside of the control center where several personnel were located (see Figure 5-1). All the personnel located in the blast lock area managed to escape the vapors by exiting through the access portal at ground level. The personnel in the control center would normally be isolated from the silo; however, two technicians involved in the spill opened the airlock door to try and obtain assistance for their supervisor who was in need of immediate medical attention. The two technicians and four other control center personnel then evacuated through the emergency escape hatch, once they realized the immediate danger of the situation. The nearby town of Rock, Kansas had to evacuate about 100 people as a result of the vapors that were escaping from the silo (see Figure 5-2).

It was later discovered that the suit of the supervisor had failed, introducing him to dangerous levels of N₂O₄ (NO₂) vapors, which was ultimately fatal to him within minutes of being exposed (see section 1.1 "Properties of Nitrogen Tetroxide (N₂O₄)" for a description of what N₂O₄ and NO₂ does to the body). Two other technicians had removed their suit hoods while in the vapor cloud. One died nine days later. The extent of the injuries of the other technician is uncertain; however, he did survive. Repairs to the damaged 533-7 silo were attempted, but later discontinued for budgetary reasons. The silo was never returned to alert status.

- Proper configuration control of GSE components, in this case the filter, is highly important in the handling of toxic chemicals, especially hypergols (root cause of the incident)
- Emergency procedures and safing must always be reviewed, practiced, and ingrained in the minds of personnel working with toxic chemicals
- Procedural oversight may have been beneficial
- Proper isolation of bulk propellant should be inherently designed into any rocket propulsion system and used accordingly during loading operations
- Personal protective equipment (PPE) should be inspected prior to every use

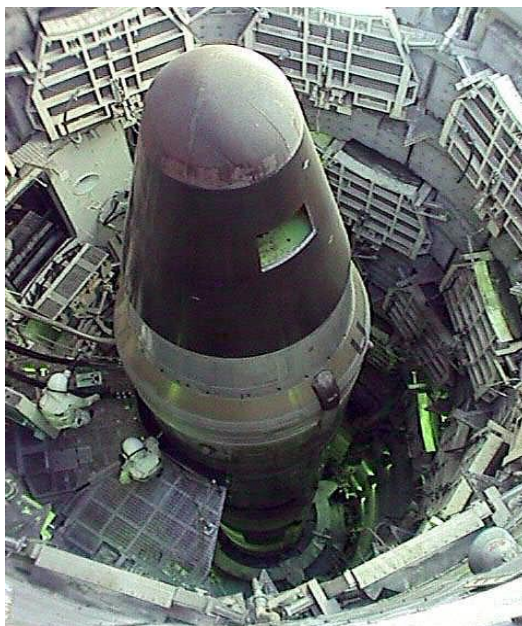
Figure 7-1: Technicians Working on Fold-Down Platform in Titan Silo Level 2

At about 6:30 PM on September 18, 1980, an airman was conducting a maintenance operation on level two (see Figure 7-1) of the underground silo when he accidentally dropped a large wrench socket. The standing platforms were hydraulically-controlled, flip-down structures with a rubber boot mounted between the platform and the rocket. The socket fell hitting the standing level two platform and bounced in the direction of the rocket where it slipped through the small gap between the rubber boot (which had become pliable over the years) and the Titan II rocket. It fell about 70 feet before hitting the thrust mount near the base of the rocket. The socket then bounced into and ruptured the stage one fuel tank (proximate cause). Approximately 11,140 gallons of A-50 drained into the bottom of the silo. Fuel vapors heated up the silo and caused the pressures in the non-ruptured propellant tanks to rise substantially.

- All workers should wear a belt with lanyards to attach tools
 - Operational human error is, therefore, the root cause
- Cloths should be placed on the platforms to prevent tools from bouncing off the metal

- The Titan II missile silo platforms should be renovated to increase safety
- The training and qualification program was insufficient prior to the incident (a root cause)

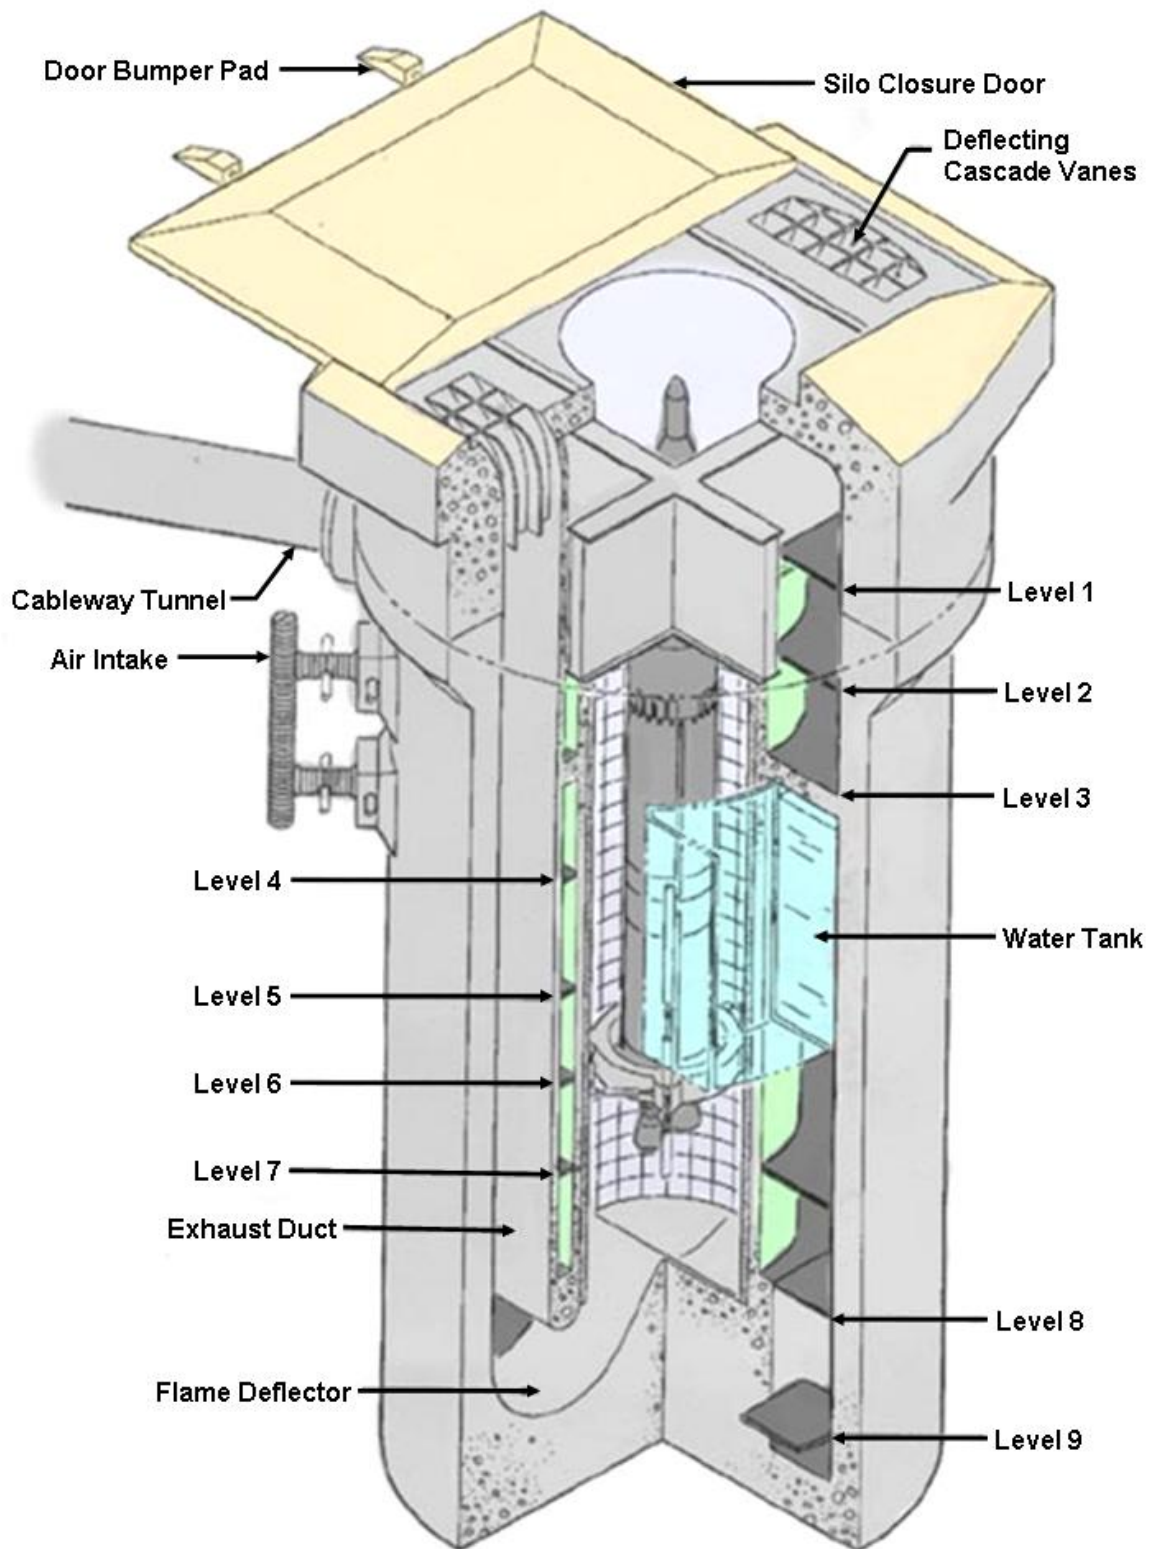
Figure 7-2: Titan II Missile Silo

It was reported that the explosion blew the 740-ton reinforced concrete and steel silo door (see Figure 7-2 for a depiction of the Titan II missile silo) 200 feet into the air and 600 feet from the silo. The rocket's second stage, with the W53 thermonuclear warhead attached, was launched out of the silo following the explosion of the first stage. The second stage then supposedly blew up in midair, (it contained about 1,730 gallons of A-50 and 3,120 gallons of N_2O_4) sending the undetonated warhead several hundred feet from the silo. The W53 warhead had a mass of 8,136 lb and a yield of 9,000 kilotons (the Hiroshima bomb "Little Boy" was estimated at about 15 kilotons). Luckily the warhead's safety features operated as they were designed. There was no reported loss of radioactive material.

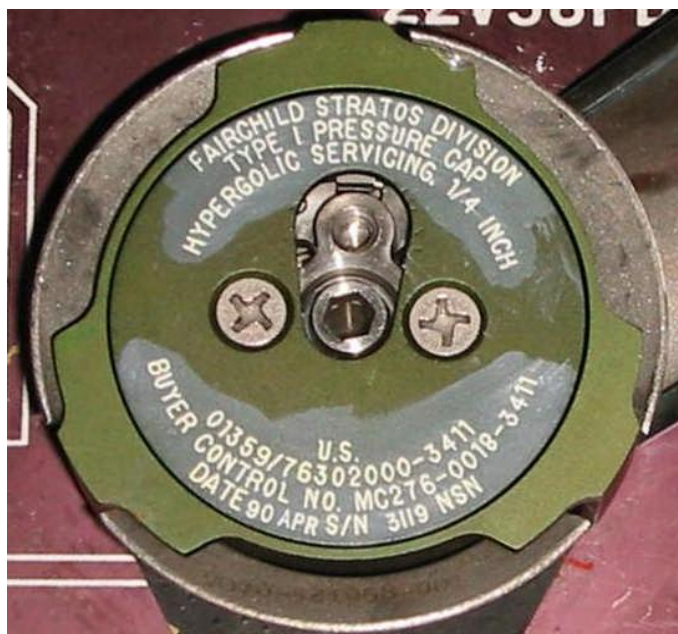
Figure 8-2: Fairchild ½-inch Flight Cap

During the MD338 flight cap installation procedure, on roughly July 14, 1981, the work step correctly called for the installation of a ½-inch cap (part number MC276-0018-2811) onto the AHC. The cap that was staged for installation was the misidentified ¼-inch cap. When a ¼-inch cap is placed onto a ½-inch

AHC, the dimensions of the stem allow for the actuation of the ½-inch AHC poppet (reference Figure 29-1 for an illustration of this) if the proper force is applied to the cap and poppet. This is exactly what happened. An oxidizer vapor release was reported when the technician tried to install the ¼-inch cap (proximate cause). The root causes are human error, improper configuration management, and improper vehicle design. The original flight cap design should not have enabled this type of incident to occur. The technician received minor injuries from exposure to NO₂ vapors. Close attention needs to be paid to the identification of flight caps and other hardware to prevent an event like this from occurring again (which it does on November 4, 1992 at WSTF).

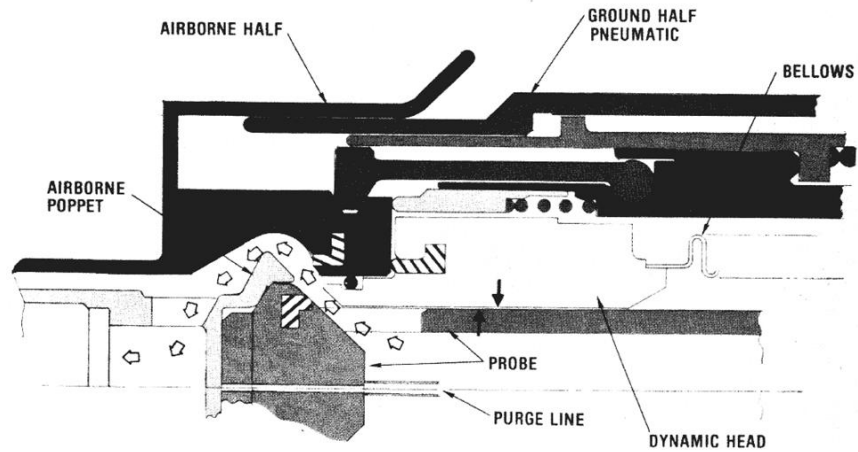
Figure 11-1: AHC and GHC in Open Position

At 1:13 AM on September 22, 1981 an N₂O₄ spill occurred at Pad 39A. The proximate cause of the spill was a failed ground half coupling (GHC), MD162, at the AP28-12 door on FRC2 of OV-102 (Columbia). Failure of the GHC was a result of iron nitrate build-up between the probe and the dynamic head of the GHC along with the tight tolerances of the GHC. See Figure 11-1, Figure 11-2, and Figure 11-3 for a description of the AHC and GHC flow paths and also the failure location. Between 15 to 20 gallons of oxidizer was released into the attached scupper, which subsequently overflowed onto the vehicle. Damage to thermal tile adhesive resulted in the removal of 370 tiles (shown in orange in Figure 11-4). The photograph in Figure 11-5 shows the thermal tiles and the underlying vehicle structure along with the scupper and QD flexhoses going into the AP28-00 door (second FRCS oxidizer servicing door just beneath the AP28-12 door when the vehicle is in the vertical orientation).

- The GHC design was flawed in that there was a single point failure resulting in a leak path (a root cause)
- The scupper and apron were not large enough to contain the spill
- Using the GHC as a shut-off valve was flawed engineering practice (another root cause)
- The emergency procedure was inadequate
- All entry paths to the FRCS module should be sealed
- Care must be taken in the control of iron nitrate which is always present in an N₂O₄ system
 - Iron nitrate and its impacts to hardware were not well understood in 1981
- Proper ventilation and lighting should be added to the FRCS room on the 207-foot level of launch pads 39A and 39B
- Emergency Launch Processing System (LPS) programs could have saved time during safing
- The communications system could have been used more efficiently

- Additional GSE valves were added to isolate the liquid N_2O_4 rather than using the QDs as valves
 - GHCs were subsequently no longer used as shut-off valves during loading
- The scuppers were upgraded through a redesign
- The QDs and AHCs were found to have very tight tolerances; therefore, the poppets were subsequently electropolished to open the tolerances
- An improved maintenance plan was implemented for the GHCs
- Improved local emergency procedures were implemented
- Entry paths to the FRCS module were blocked with tape and RTV (adhesive)
- Improved controls were put in place to minimize the amount of iron nitrate in the liquid N_2O_4
- The lighting in the FRCS room was enhanced
- LPS improvements were made including automatic remote safing that was keyed from local toxic vapor detection devices

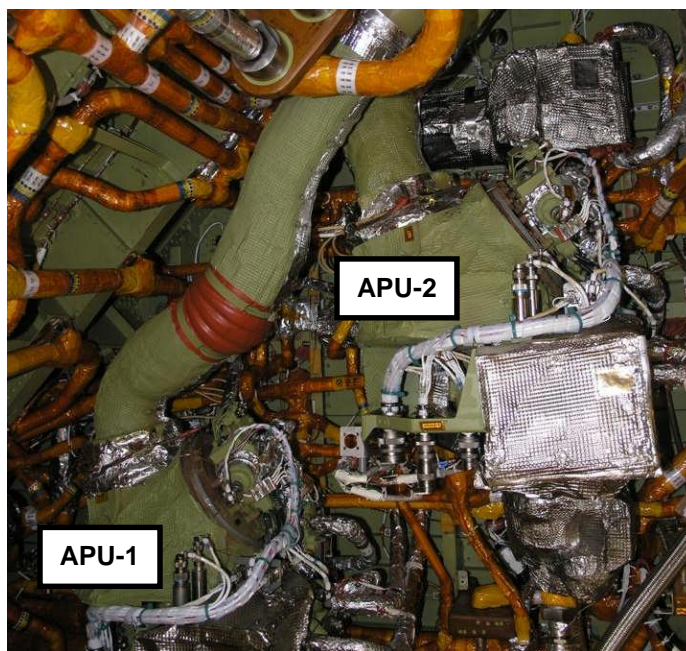
Figure 15-2: APU-1 and -2 in a Nominal Configuration

On December 8, 1983, Space Shuttle Columbia landed at EAFB at 3:48 PM pacific local time, concluding the STS-9 mission. About seven minutes after landing, an unusual series of events occurred. First, APU-1 shut down prematurely in response to a sensed turbine "underspeed" condition. About four and a half minutes later an explosion occurred in the APU. Figure 15-1 shows what remained of the APU-1 fuel pump following the explosion along with the resulting collateral damage. At the instant of the APU-1 explosion, APU-2 spontaneously shut down. Fifteen minutes later it exploded. Figure 15-2 is a photograph of APU-1 and APU-2 in the aft of OV-105 (similar to the OV-102 configuration). APU-3 ran nominally.

Following the STS-9 flight, several changes were made to the APU subsystem, including soaking of the carbon seals in hydrazine prior to installation, chromizing the injector stems to prevent corrosion, and minimizing stresses on the injector stems during manufacturing and installation. These design flaws are believed to be the root causes of the incident.

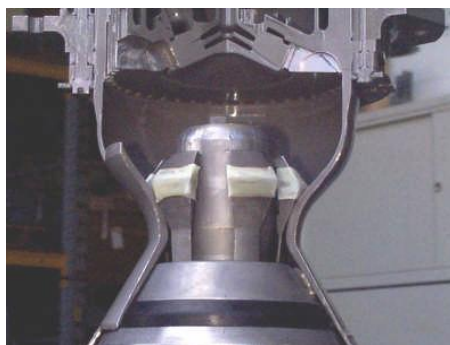
Figure 18-1: Space Shuttle Thruster Chamber Cutaway with Purge Adapter Installed

On May 24, 1985, while preparing for the removal of R4D (down-firing thruster on the Space Shuttle right pod) from OV-099, there was an MMH spill in OPF1 on the 10-foot level west side. R4D was being removed as a result of an in-flight anomaly related to a heater failure on the thruster. The manifold had been drained of its propellant and it was thought that a purge through the MD348 line (which connects to the manifold) and out the thruster nozzle purge adapter was sufficient to remove the liquid and most of the fuel vapors. Figure 18-1 shows a purge adapter in a cutaway of a primary thruster nozzle. During the part of the procedure where the purge adapter was being removed, approximately one cup of liquid MMH spilled from the thruster and down onto the body flap (which is illustrated relative to thruster R4D in Figure 18-2). The body flap was partially covered with spill protection sheets. The OPF1 hypergol exhaust fans were activated and the facility was immediately evacuated. It was recorded that some of the liquid MMH had saturated the body flap tile filler bar. It is unknown if the tile had to be removed. Unlike N_2O_4 , which was known to breakdown Koropon primer (from the STS-2 N_2O_4 spill mentioned previously), the effect of MMH on Koropon was not well known in 1985.

There are three possible proximate causes to this spill. A combination of two or more of the following causes is also possible. The first involves an improper configuration in which the flexhose that was being used for the procedure had previously been utilized for a similar operation on the left pod thruster L1U's manifold. This flexhose was several feet longer than the flexhose that was normally used for the right pod manifold evacuations. It was routed from the R4D thruster purge adapter to the 19-foot level above, then down to the eductor on the 10-foot level. This excessive length in hose may have allowed for a "u-shaped" low point trap to be formed in which liquid MMH could have collected. The second possible proximate cause involved a procedural error made by the engineers on console. The evacuation could have created a pressure differential across the liquid MMH. When the eductor was deactivated and removed, this pressure differential may have pushed the liquid into the thruster chamber. The third possible proximate cause was the liquid had collected in the thruster chamber (see Figure 18-1) and the purge was of insufficient duration to remove all the liquid MMH or the liquid trap may have prevented the vacuum source from evaporating all the residual fuel that remained around the purge adapter. A definitive proximate cause was never determined.

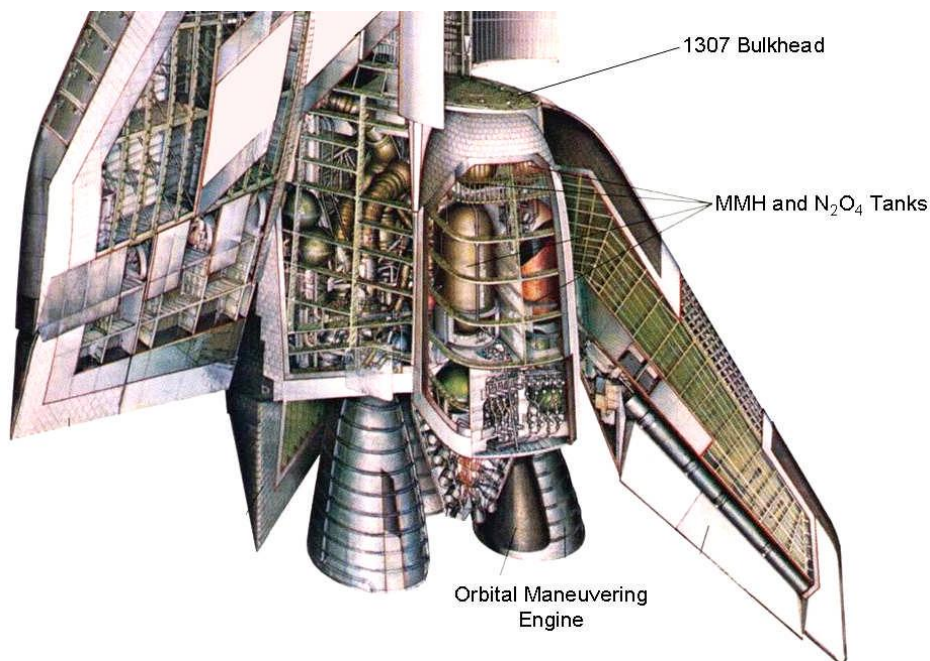
Figure 24-1: Cutaway View of Space Shuttle Orbiter Aft

On July 14, 1988, about three days after the loading of N_2O_4 onto Discovery at Pad 39B for the STS-26R Return to Flight mission, a small N_2O_4 (NO_2) vapor leak was detected in the left OMS pod (LP04) of Discovery. STS-26R was the first flight following the Challenger disaster on January 28, 1986. The leak did not result in any injuries or hardware damage, but it did impact the launch date of Discovery. Along with several other Return to Flight actions, the launch team at KSC was required to test fire the three main engines on Discovery while it was at the launch pad. This was known as the Flight Readiness Firing (FRF) and was scheduled to occur on July 26, 1988. The Space Shuttle Program decided to complete the FRF regardless of the known oxidizer vapor leak; therefore, the engineering team assigned to assess the leak had a couple weeks to study possible solutions, while other groups were preparing for the FRF.

First, the exact location of the leak within the pod had to be found (a cutaway view of the Space Shuttle OMS pod can be seen in Figure 24-1). This was difficult because the internals of the aft pods and forward module are not meant to be accessed while the vehicle is at the launch pad. The location of the leak had been isolated to the LRCS N_2O_4 system or the associated tubing through monitoring of the instrumentation in the LCC. The leak was measured to be 0.26 psi per hour (about 800 standard cubic centimeters per hour) and a TVC found the concentration of NO_2 vapor to be 15 ppm at the vehicle vent door. This later decreased to 3 ppm. An access door was removed on the pod's outer skin and several internal thermal blankets were removed. A long section of PVC pipe was then inserted into the pod to function as a guide for a borescope. Using a borescope, the leak was finally isolated (after a six hour search) to a ½-inch dynatube fitting on the MD224 leg (the N_2O_4 propellant tank ullage vent). A cross-section view of a dynatube is shown in Figure 24-2 and a photograph of the leak location can be seen in Figure 24-3.

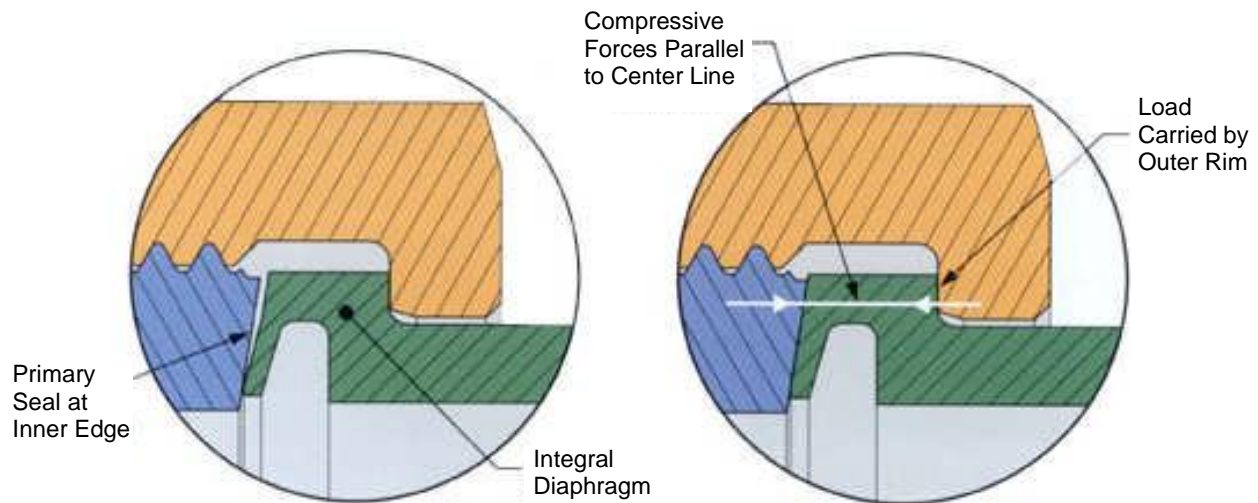
Figure 24-2: Cross-Section of Dynatube Sealing Surface

The proximate cause of the leak was found to be a scratched dynatube. This was discovered during ground processing two missions later when the pod was removed in the OPF and sent to the HMF for repair. It was determined that the scratch must have occurred either when the dynatube was disconnected in October of 1987 to allow access to a nearby valve for a removal and replacement or when it was reconnected in late December of 1987. Following the reconnection, the dynatube fitting passed all leak checks. Transport vibrations may have “altered” the state of the connection between the HMF, OPF, and launch pad; however, this is highly unlikely since dynatubes do not typically change mechanical state, especially with safety wire installed. The Kersey report states that “The most probable cause was that the mass spectrometer probe operator probed the wrong RCS propellant system (i.e. MMH instead of N_2O_4).” Operational human error was the root cause of this incident along with improper training. This categorization was given as a result of the incident being a consequence of either an inadequate inspection of the dynatube sealing surface or an error made during the leak check of the dynatube.

After a week of deliberation, the “clamshell” was selected as it was the least invasive method to stop the leak prior to launch and it could be completed at the launch pad. Furmanite FSC-6B was used as the sealing compound as a result of it having the best compatibility characteristics with N_2O_4 . The FRF was finally completed on August 10, 1988 following a few hardware-related delays. The repair of the oxidizer vapor leak began on August 17, 1988 with the cutting of two holes in the aft 1307 bulkhead (the bottom of the payload bay with the orbiter in the vertical orientation) and the top of the pod beneath the bulkhead. The dynatube’s safety wire was removed and a “clamshell” (shown in Figure 24-5) was placed over the leak. The Furmanite sealing compound was then injected. The leak was eliminated; therefore, the Space Shuttle Program cleared Discovery for launch, which successfully occurred on September 29, 1988, a few weeks later than the original launch date of September 6, 1988. The delay was a result of multiple items including the FRF test delays, return to flight SRB testing delays in Utah, and the N_2O_4 leak on LP04.

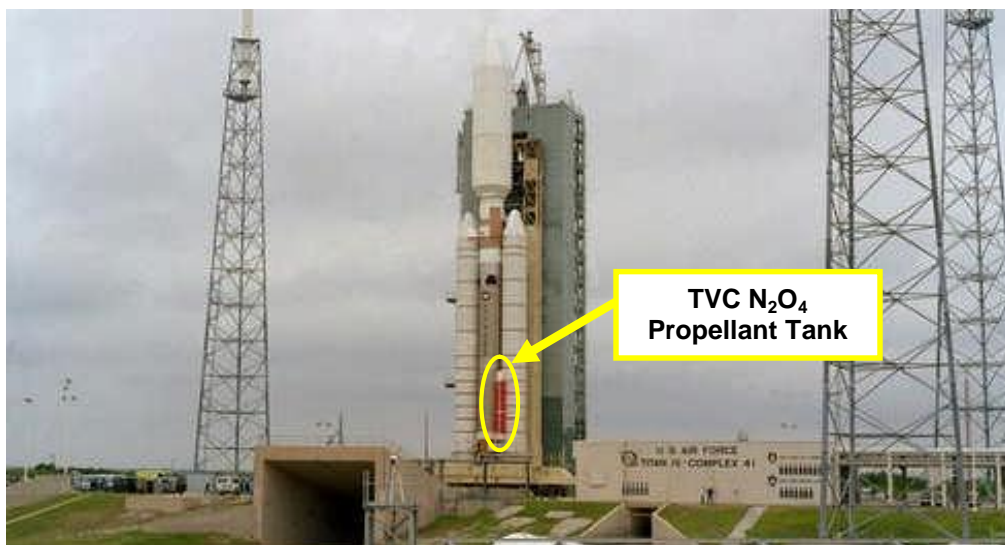
Figure 31-1: SLC-41 with Titan IV A (Servicing Structure Retracted)

On August 20, 1994, at Space Launch Complex 41 (SLC-41) on CCAFS there was a large release of liquid N_2O_4 . Oxidizer was being loaded into the Titan IV A's solid rocket motor (SRM) thrust vector control (TVC) system in preparation for the launch of the National Reconnaissance Office's Mercury Electronic Intelligence or ELINT satellite on August 27, 1994. The N_2O_4 was used to alter the combustion in the Titan IV A SRM nozzle and, therefore, provide TVC. A photograph of the SLC-41 launch pad with a Titan IV A is shown in Figure 31-1. A diagram of the Titan IV A's TVC system is shown in Figure 31-2 with the numbered callouts listed in Table 31-1. The incident occurred about three and a half hours after sunrise

when the solar heat caused the pressure to increase in the N_2O_4 tubing while the system was in a static configuration.

The pressure increase went unnoticed by the engineers and technicians. Remote data monitoring was available on the launch vehicle, but not on the propellant transfer systems (GSE). Local dial gauges likely showed the increase in pressure; however, there were no technicians monitoring these particular gauges. The pressure rise eventually caused a weld seam to fail at the base of the transfer system (proximate cause). This portion of the N_2O_4 servicing GSE lacked a relief valve, thus allowing the propellant in the tubing to become “liquid locked” since a drain-back and purge had not been completed (improper design; a root cause). There was no damage to the GSE (excluding the ruptured tubing) or vehicle hardware and there were no reported injuries.

Another root cause of this incident was determined to be frivolous procedure deviations. The loading team and Launch Conductor had experience with successfully delaying the oxidizer drain-back and purge; however, this experience was based on insulated oxidizer tubing. The tubing at SLC-41 had recently been removed and replaced with non-insulated tubing as a result of the moisture trapped in the insulation causing accelerated corrosion. The loading team and the Launch Conductor either did not recall this or they were never told.

There are requirements for launch Pads 39A and 39B to have seamless pipe throughout and to have relief valves in tubing that could become “liquid locked.” Following the incident at SLC-41, the procedures were changed to preclude this sort of incident from happening in the future. The procedure deviation approval rules were also reaffirmed to the loading team and Launch Conductor.

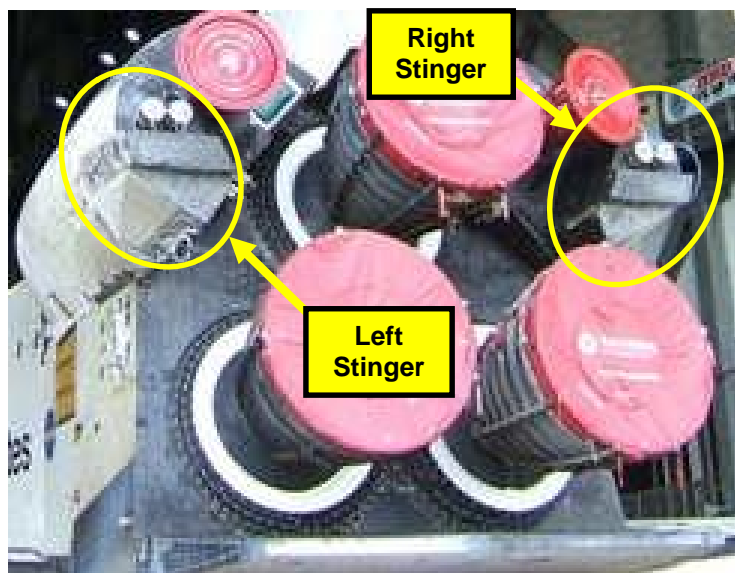
Figure 32-1: Stinger Locations on Orbiter

During the STS-69 OV-105 flow, while performing a thruster L3D removal and replacement, an MMH flame was reported in the Space Shuttle left OMS pod stinger area (see Figure 32-1 for the relative location of the stingers). The technician in SCAPE was preparing to inspect the dynatube (approximately an hour after the thruster was removed) with a mirror when he reported a small flame on the MMH thruster feedline dynatube. Another technician was unable to find any water to put out the fire and mistakenly picked up an alcohol bottle and sprayed the flame which produced a small flash near the feedline, igniting the residual MMH inside it. It is believed that the technician thought the spray bottle was Freon. It was reported that the flame was extinguished by the technician placing his SCAPE glove over the dynatube end. This was probably not the best idea since MMH can react exothermically in a rigid volume and burn in an atmosphere 2.5% to 98% by volume in air.

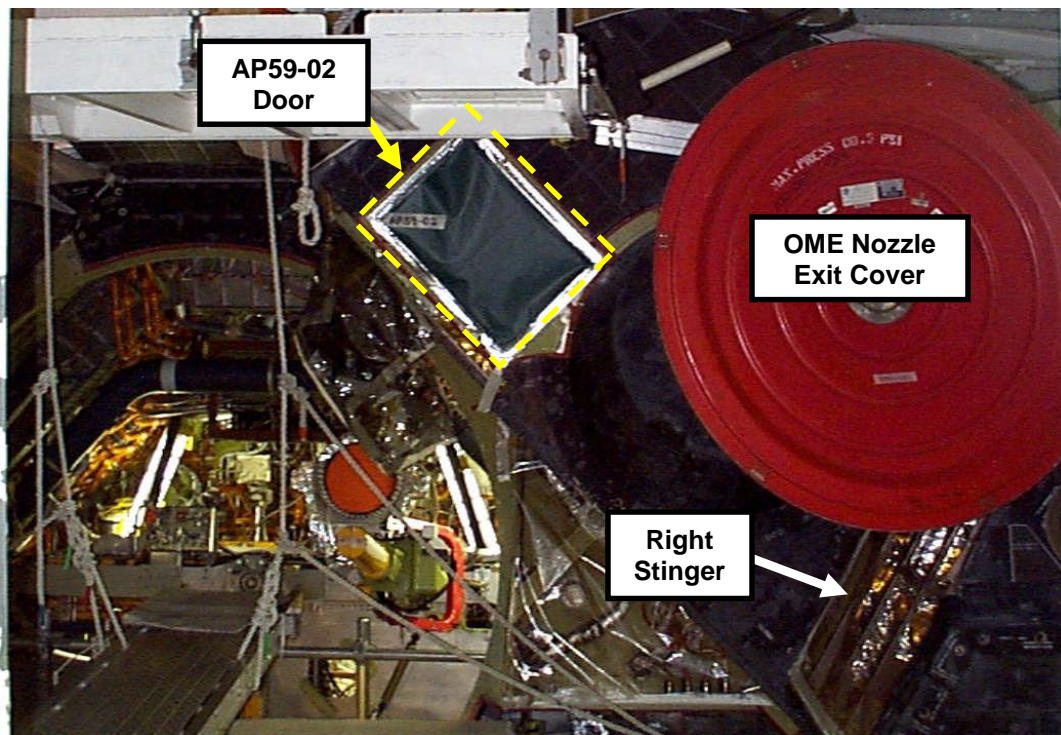
Figure 33-2: Color Photograph of Right Pod and Orbiter Aft

During the STS-69 OV-105 flow, while performing a thruster R1A removal and replacement, a fire broke out in the Space Shuttle right OMS pod stinger area. The fire burned strongly for about 30 seconds and a smaller flame burned for about one minute and 45 seconds. The size of the flame was estimated to be approximately 15 inches x 11 inches x 11 inches with a damage region of approximately 22 inches x 14 inches x 14 inches in the stinger. The materials that burned included several ounces of fuel, a shop light, and the Orcofilm spill protection (flame retardant covering films). Figure 32-1 is a still image from the video recording during the fire and Figure 33-2 is a clearer color photograph of the same area for reference.

A technician in SCAPE was disconnecting the R1A thruster MMH feedline dynatube during a thruster removal and replacement procedure. The procedure was initiated following an in-flight anomaly that occurred on the thruster during on-orbit operations (R1A primary thruster failed off due to a low chamber pressure). The N_2O_4 dynatube had already been disconnected and double-bagged in attempt to contain the residual vapors that were being released from the fitting. The technicians were told to place an aspirator near the N_2O_4 dynatube and proceed with the fuel feedline disconnect operation. When the seal of the fuel dynatube was broken by the technician using a wrench, he noted that there were “large drops of fuel being siphoned away by the aspirator.” Immediately following this, a fire erupted. There were six SCAPE personnel in the area when the fire was first reported. The proximate cause of this incident was the disconnection of the dynatube without knowing that there was liquid fuel within the tubing.

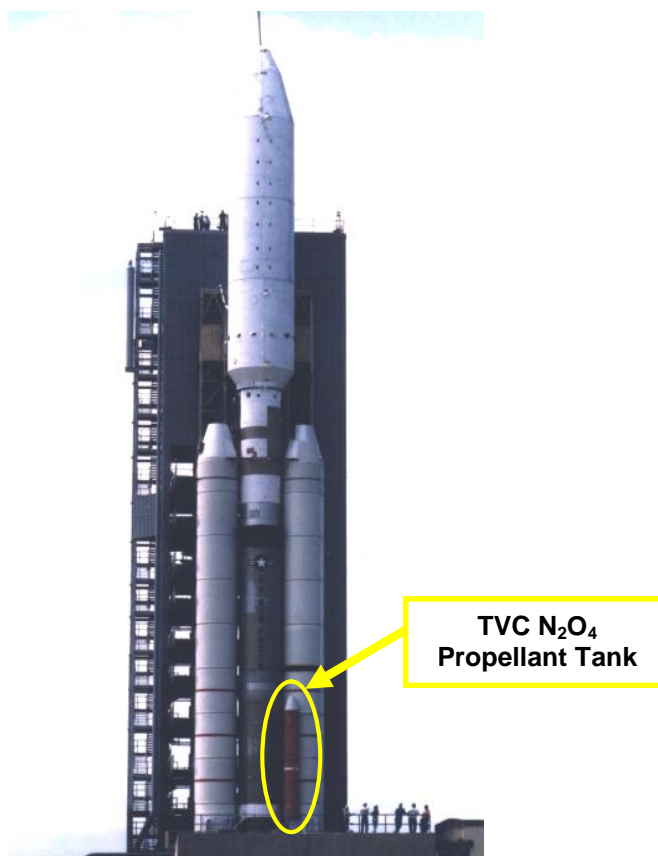
Figure 37-1: Titan IV A on Launch Pad

On July 16, 1997 engineers at VAFB SLC-4E were remotely pressurizing the two N₂O₄ propellant tanks, one each on the two Titan IV A's SRM TVC systems. Reference Figure 31-2 for a diagram of the TVC system. The propellant tank servicing was completed without incident about nine days prior to the pressurization. Each tank contained about 8,400 lbs (702 gallons) of liquid N₂O₄. The rocket was being prepared for a planned mid-July 1997 launch on a Department of Defense mission to replace an aging reconnaissance satellite. Figure 37-1 shows a Titan IV A configuration at its launch pad and points out the location of the N₂O₄ tank.

About 20 minutes after initiating the propellant tank pressurization, liquid N_2O_4 was observed to be streaming out of the aft skirt heat shield region on *both* SRMs. There were no reported injuries and the flight hardware had minimal collateral damage (mainly on the SRM nozzles). At the time of the observed N_2O_4 release (likely initially noticed by the signature brownish-orange NO_2 vapors characteristic of an N_2O_4 spill) the propellant tanks were at a pressure of about 830 psi. The target pressure was about 1,040 psi. The engineers quickly began to depressurize the propellant tanks, which had the immediate affect of decreasing the rate of propellant release. The tanks were vented from their initial pressure of about 830 psi to a final pressure of 38 psi, at which time the N_2O_4 release ceased. At that time, all systems were secured and the operation terminated. It was decided to offload all of the propellant from the subject tanks, so about eight hours later, the engineers and technicians began the offloading procedure. This operation was completed without incident. Following the offload and evacuation of the TVC N_2O_4 system and tubing, the total amount of propellant transferred was estimated. About 1,160 gallons of N_2O_4 was re-captured as a result of the drain-back. This logically implies that about 244 gallons of N_2O_4 was released to the atmosphere.

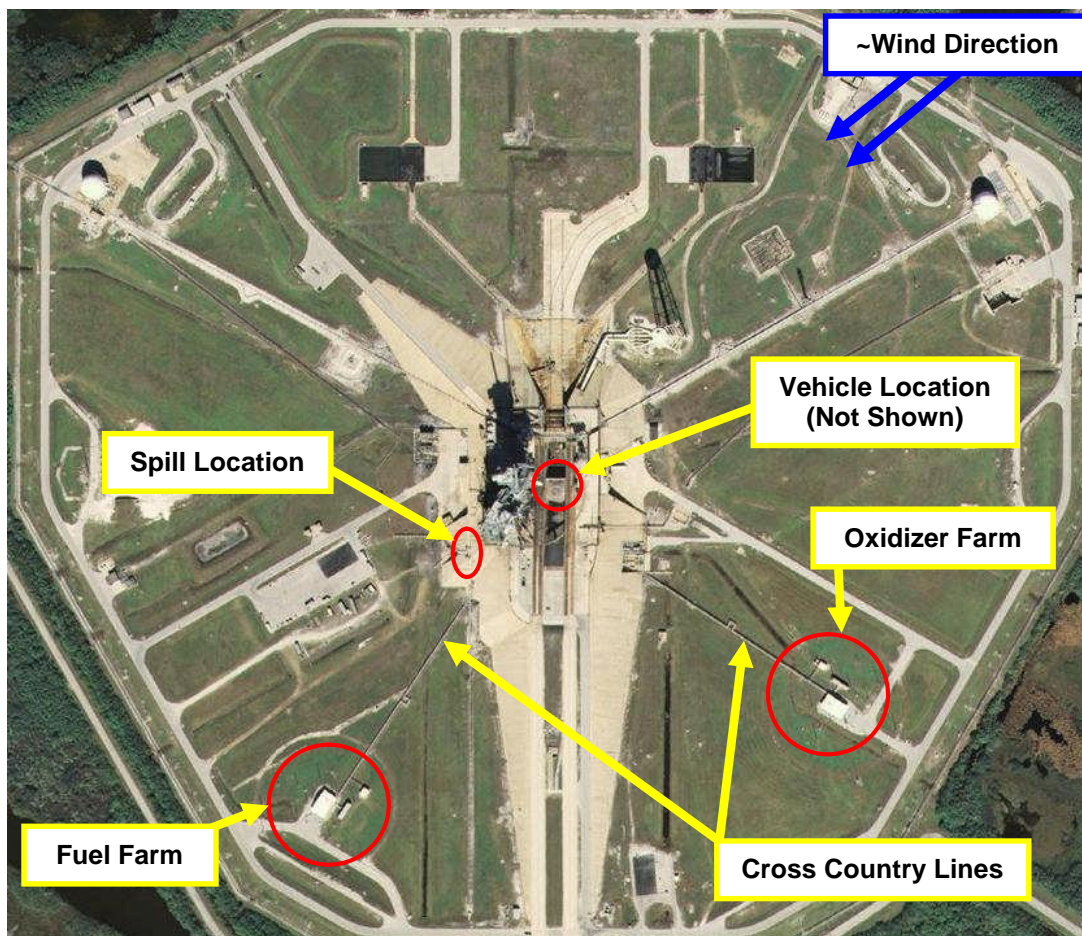
Figure 38-1: Geographic Layout of Launch Pad 39B

The SCAPE van driver was the first to detect the spill when he smelled oxidizer in the area of the fuel farm (see Figure 38-1 for a geographic layout of Pad 39B). Safety officials at the launch pad perimeter noted the source of the oxidizer vapors was the Pad 39B west slope. Three technicians in SCAPE were directed to proceed to the general area of the vapor source from their location on launch pad tower 107-foot level. Upon arrival, the technicians noted that heavy N_2O_4 (NO_2) vapors were leaking from both the inlet and outlet flanges of the return cross-over valve. They also noted that there were still several

gallons of liquid N_2O_4 on the ground near the flanges and at the bottom of the slope in a grassy area. Sparks were seen shortly after the arrival of the technicians; therefore, two of the three evacuated. Some of the liquid N_2O_4 that had flowed down the slope incline contacted the electrical conduits routed along the ground that supplied power to nearby lighting. The technicians were unaware that the N_2O_4 had dissolved some of the cabling insulation.

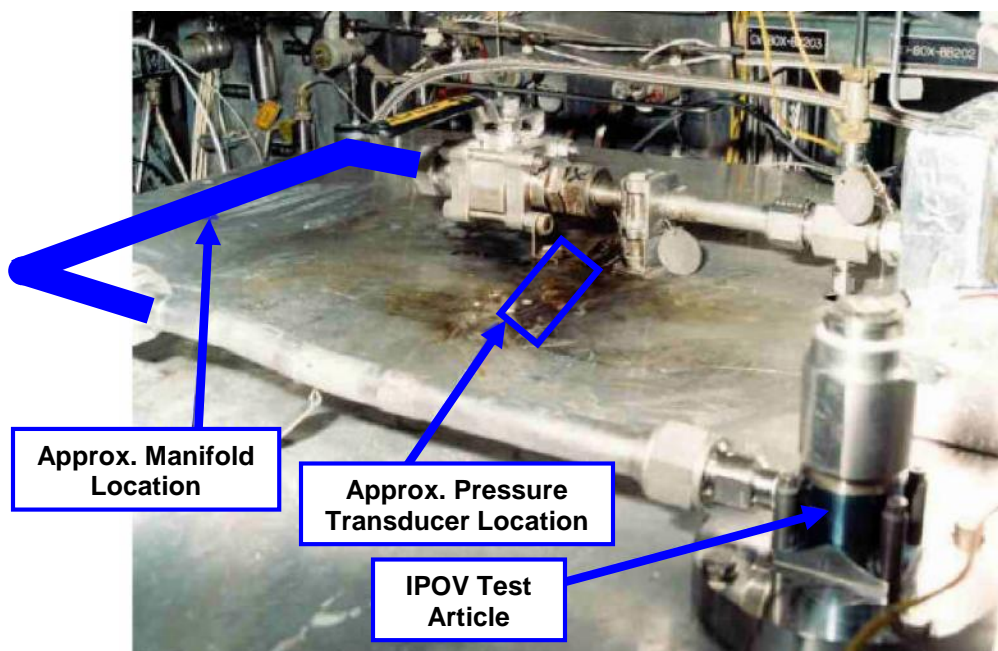
Figure 42-1: IPOV Test Setup

On March 25, 2003, in Test Cell 831 at WSTF, during the life cycle testing of an N₂O₄ Improved Pilot Operating Valve (IPOV), there was an explosion. Following the explosion, there was an N₂O₄ vapor release (approximately three quarts) into the test cell. There were no reported injuries since the cell was vacated prior to starting the test. It was found that a pressure transducer had catastrophically failed as a result of a material incompatibility within the pressure transducer (proximate cause). Figure 42-1 is a photograph of the test setup following the explosion with the relative location of the pressure transducer prior to the explosion.

Initial inspections of the pressure transducer indicated that the transducer failed as a result of one of the following: over-pressurization, inadequate design, or cyclic fatigue at a highly stressed location. Since the pressure transducer failed, data from it at around the time of the failure may be suspect; therefore, the investigation included a detailed inspection of the nearby system tubing to determine if there was an over-pressurization event. Close inspection of the pressure transducer itself would indicate if the transducer failed from cyclic fatigue or was subject to a ductile failure from a single overload event.

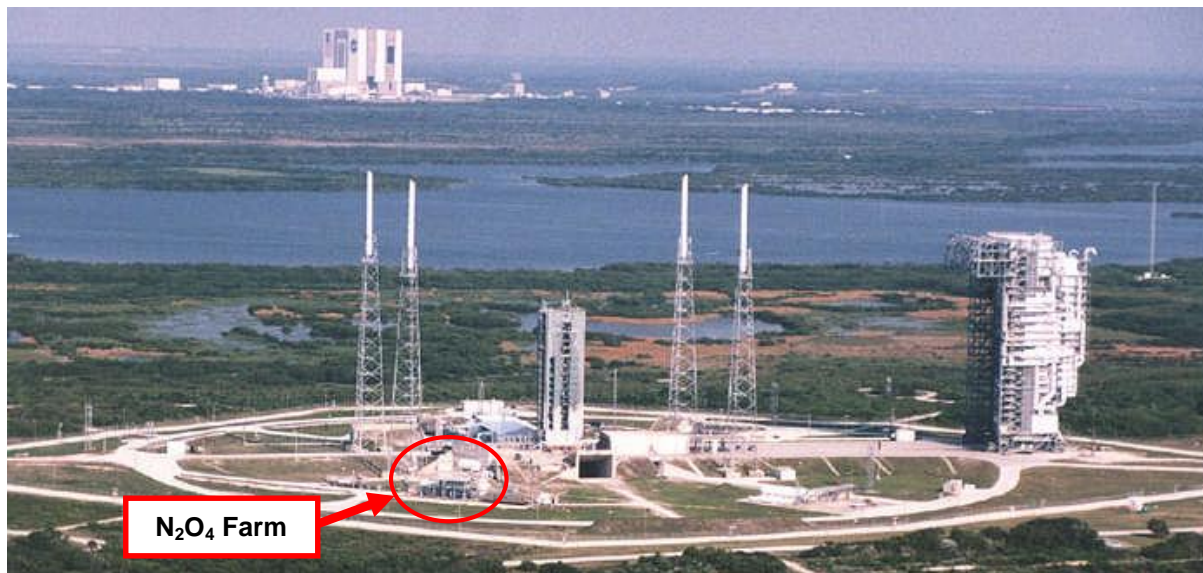
Figure 43-1: LC-40 at CCAFS

On August 12, 2003, at CCAFS launch Pad LC-40 (shown in Figure 43-1) during the bleed-in operation for the B36 Stage II (Titan IV) propellant load, the oxidizer centrifugal pump exploded (proximate cause of the N₂O₄ spill). The Titan IV launch vehicle was being loaded in preparation for the September 9, 2003 launch of the National Reconnaissance Office's payload. Along with the liquid N₂O₄ release of approximately 40 gallons, the explosion created a large amount of shrapnel which caused significant damage to the surrounding GSE. The pump was completely destroyed as shown in Figure 43-2. Fourteen people reported to an on site health facility. They were all later released without injury. The storage tank holding several thousand gallons of liquid N₂O₄ remained intact with minimal damage. An extensive investigation was initiated as a result of the Space Shuttle Program using these same pumps at Pads 39A and 39B (eight pumps in four locations) along with the Titan program which used them at LC-40.

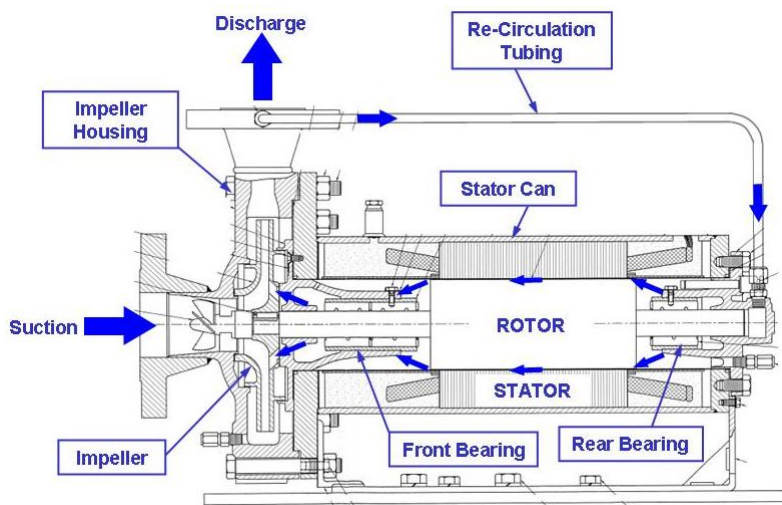
Figure 43-3: Pump Schematic

The incident failure analysis concluded, according to Crass, that there was a “cooling anomaly at the [carbon graphite journal] bearings...leading to [an explosion] in the stator can winding area.” It was found that the most likely contributor to this was a clogged filter in the pump recirculation loop that circulates liquid through the rotor cavity to cool the front and rear bearings as illustrated in Figure 43-3. Data analysis showed that the upstream and downstream temperature transducers indicated an increase in temperature of 8 °F across the pump. The low flow rate of 40 gpm and high ambient temperatures (high of 86 °F for 8/12/2003) accelerated the failure of the pump. At these flow conditions, the pump was not

able to be properly lubricated as a result of the high vapor pressure of liquid N_2O_4 (these particular pumps are designed to be lubricated with the liquid that they are pumping). The excessive bearing wear led to damage to the stator liner can, allowing oxidizer to leak onto the hot copper windings. The N_2O_4 reacted with the copper winding insulation and caused the coil wire to short, which was the proximate cause of the explosion.

Following the explosion, there were some design changes made to the pumps since an improper pump design was a root cause, these changes include the following:

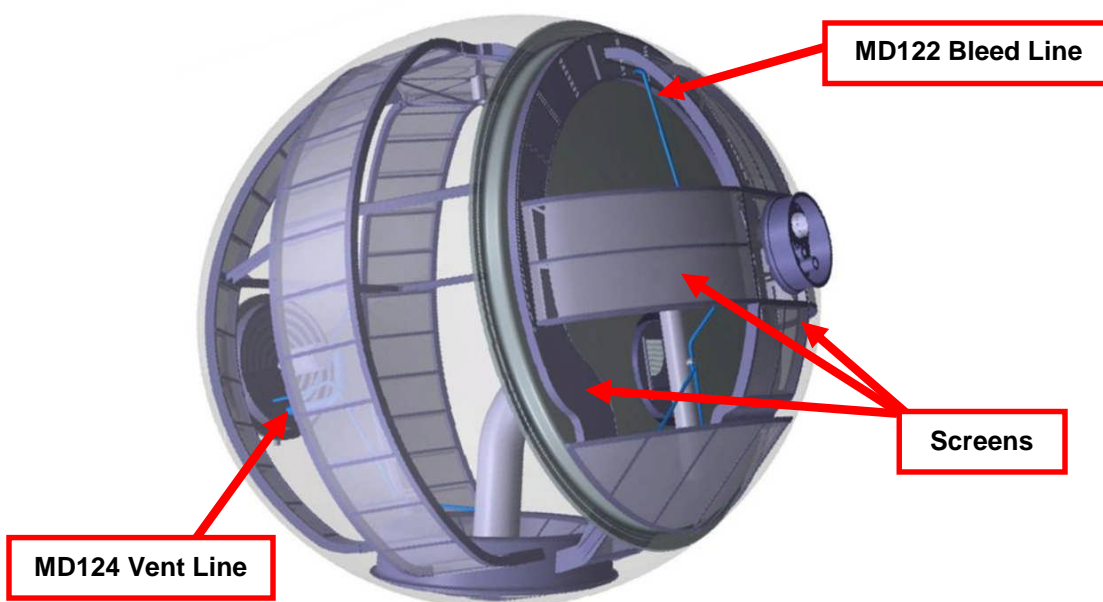
Figure 46-1: Solid Model of RCS Propellant Tank in (Roughly) the Horizontal Orientation

With the vehicle in a horizontal orientation, the MD122 line runs from the high point of the oxidizer tank lower compartment channel, through an interface at the tank outlet flange, and out to an AHC located in an externally accessible door on the FRCS outer mold line (AP28-00 door). It is known through pressure measurements that the MD122 and MD120 connected GSE lines were clear of any liquid immediately following the two, five-minute purges; however, it is not known if the propellant acquisition system channel in the lower compartment was broken down (i.e. it did not contain any liquid). If the screen was not completely broken down, it is possible that liquid oxidizer “wicked” up the screen following the purges to the point where MD122 connects to the acquisition screens. See Figure 46-1 for visual aid of the propellant acquisition system screens and the MD122 line. The absence of liquid in the lines can be confirmed by noting that there was not any significant pressure increase in the lines. The tank was *not* in thermal equilibrium. The tank shell (skin) temperature rose from 49 °F, when tank venting was complete, to 58 °F, when MD124 GSE vent valve was opened for the emergency vent through MD124 in the upper compartment of the tank. When the two purges were complete the tank shell temperature was 54 °F. From the time of the spill to the emergency MD124 vent, the tank shell temperature rose from 57 °F to 58 °F. The fluid and gas temperatures likely rose by a degree or two during this time.

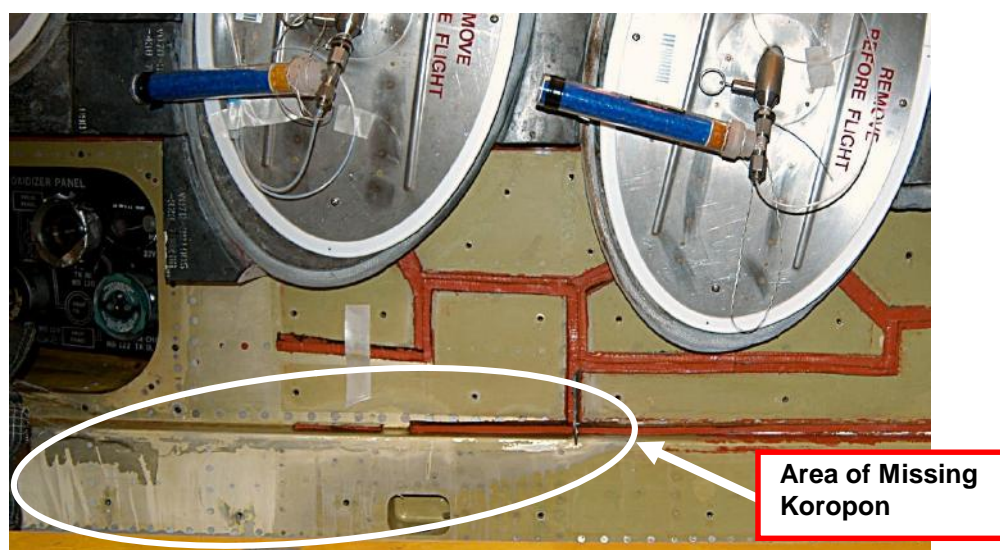
Figure 46-3: View Looking at R/H Side Down-Firing Thrusters (F2D & F4D)

The spilled oxidizer appears to have reacted with Koropon, RTV, and silver plating (nutplates and barrel nut elements). The oxidizer vapors reacted with the Koropon and removed a large area, as shown in Figure 46-3, and passed through the nutplate holes and around the perimeter of the phenolic QD service panel into the interior of the FRCS module, as shown in Figure 46-4, causing damage to the Koropon on the interior side of the FRCS module.

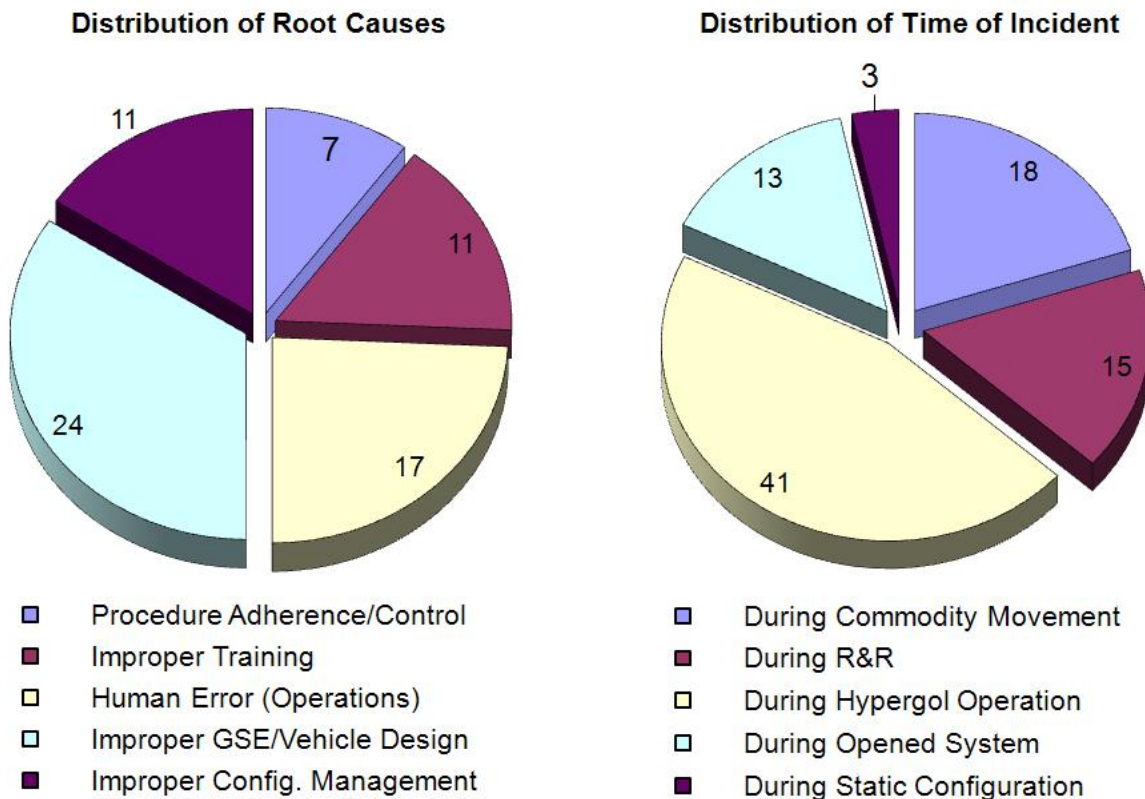
Figure 47-1: Distributions for Root Cause and Time of Incidents

Table 47-1 and Figure 47-1 summarize the fuel and oxidizer incidents. Note that if the numbers in the table are totaled, they do not sum to the total amount of fuel and/or oxidizer spills summarized in this document. This is a result of some incidents having injuries and a fire or multiple root causes, for example. A larger, more extensive list of the data shown in Table 47-1 can be seen in Appendix C: Detailed Assessment of Incidents.

Root Causes:

7 Procedure Adherence/Control (engineer or technician did not follow procedure or protocols were ignored)
 11 Improper Personnel Training (engineers or technicians were untrained or too inexperienced)
 17 Human Error (technician and/or engineers making a real-time error)
 24 Improper GSE/Vehicle Design (improper materials, unknown low points, incompatibilities, etc.)
 11 Improper Configuration Management (system configuration and upkeep errors that led to an incident)

Incident Occurred During:

18 During Commodity Movement
 15 During an R&R Procedure
 41 During a Nominal Hypergol Operation
 13 During Opened Hypergol System
 3 In a Static Hypergol System
